DRAFT
PHASE I ENVIRONMENTAL SITE ASSESSMENT
DISTRICT OF COLUMBIA PROPERTIES
POPLAR POINT, WASHINGTON, D.C.

PREPARED FOR THE
NATIONAL OCEANIC AND ATMOSPHERIC ADMINISTRATION

Prepared by
Ridolfi Engineers Inc.

May 17, 2002

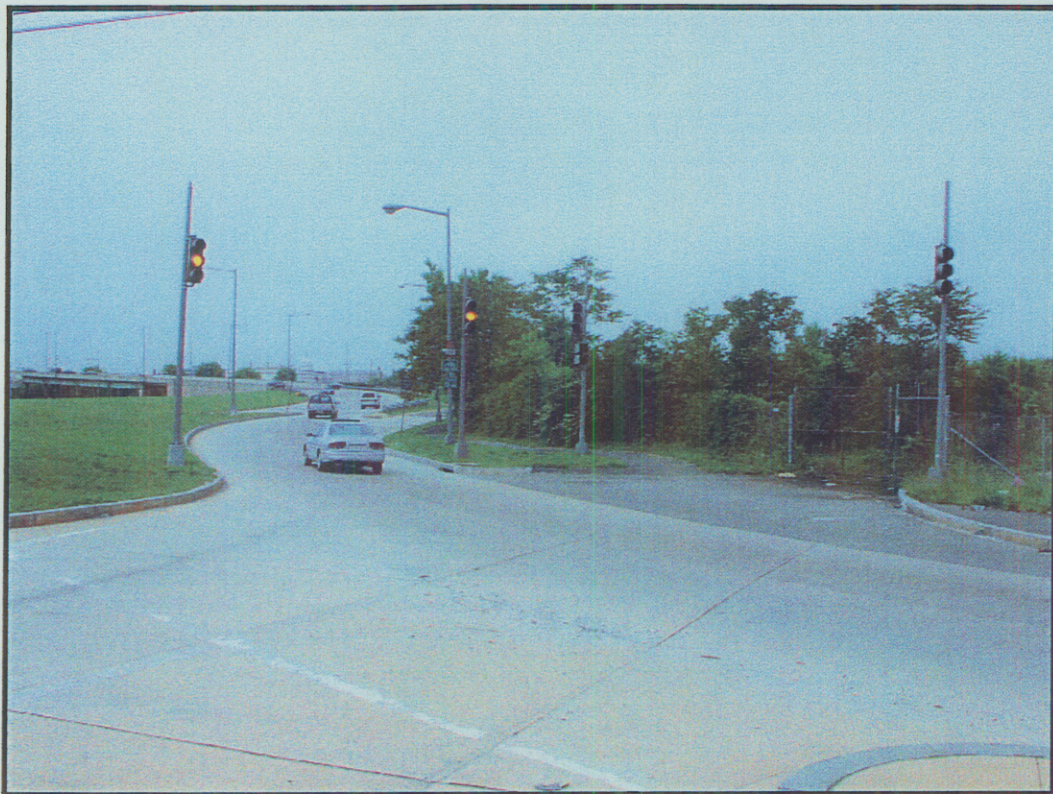
Properties 5860-938 and 5860-960 (identified here by block and lot numbers) were accessed from a gate located near the intersection of Howard Road S.E. and Suitland Parkway. A paved driveway was observed running from Howard Road S.E. towards the north on the property that adjoined 5860-938 to the east. No buildings or structures were observed on Properties 5860-938 and 5860-960 at the time of the walkover. Thick low-lying vegetation was present, which limited Ridolfi's ability to view the ground surface in some areas. Properties 5860-938 and 5860-960 consisted of vacant land with trees and brush. Scattered surface debris, consisting of plastic, glass, and paper was observed along the western and southern portions of

Photo 1: Overview of southern portions of 5860-960 and 5860-938, facing north. Note: Frederick Douglas Memorial Bridge on left side of photograph.

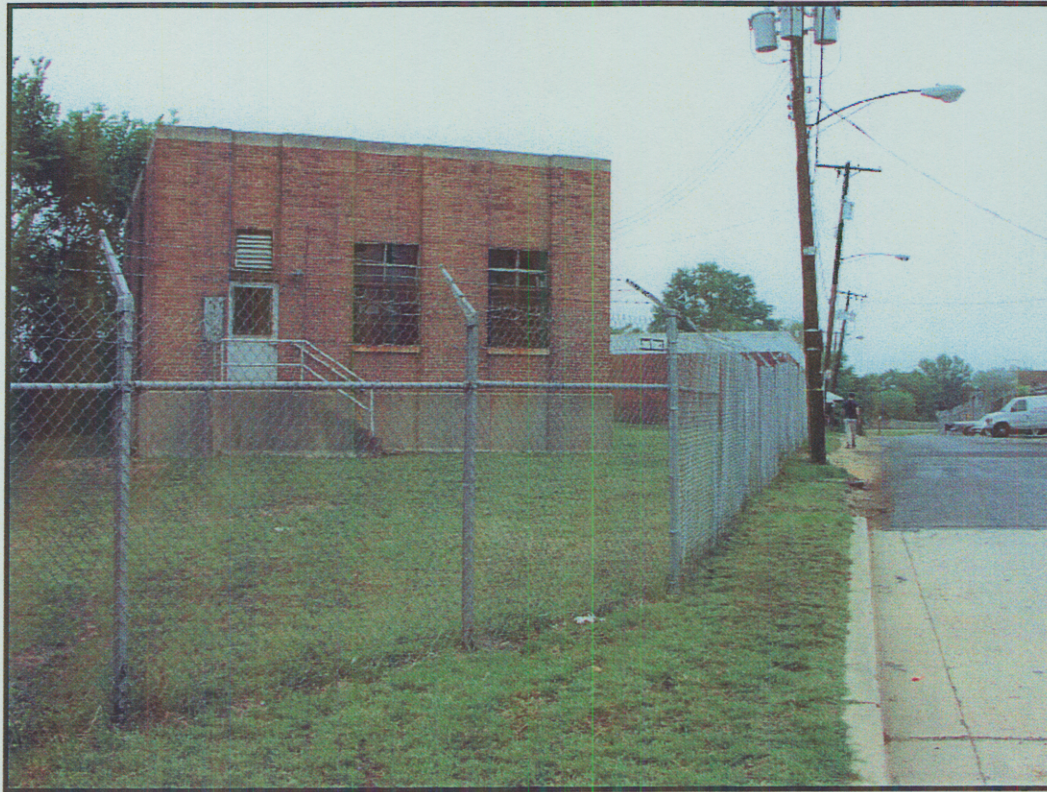
Three pole mounted electrical transformers were observed near the northern portion of 5864-808. No signs of staining were observed on the transformers or on the ground surface below the transformers. The transformers did not appear to represent RECs in connection with the Project Study Area.

Photo 5: Overview of 5864-808, facing northeast. Note: pole mounted transformers on top right portion of photograph.

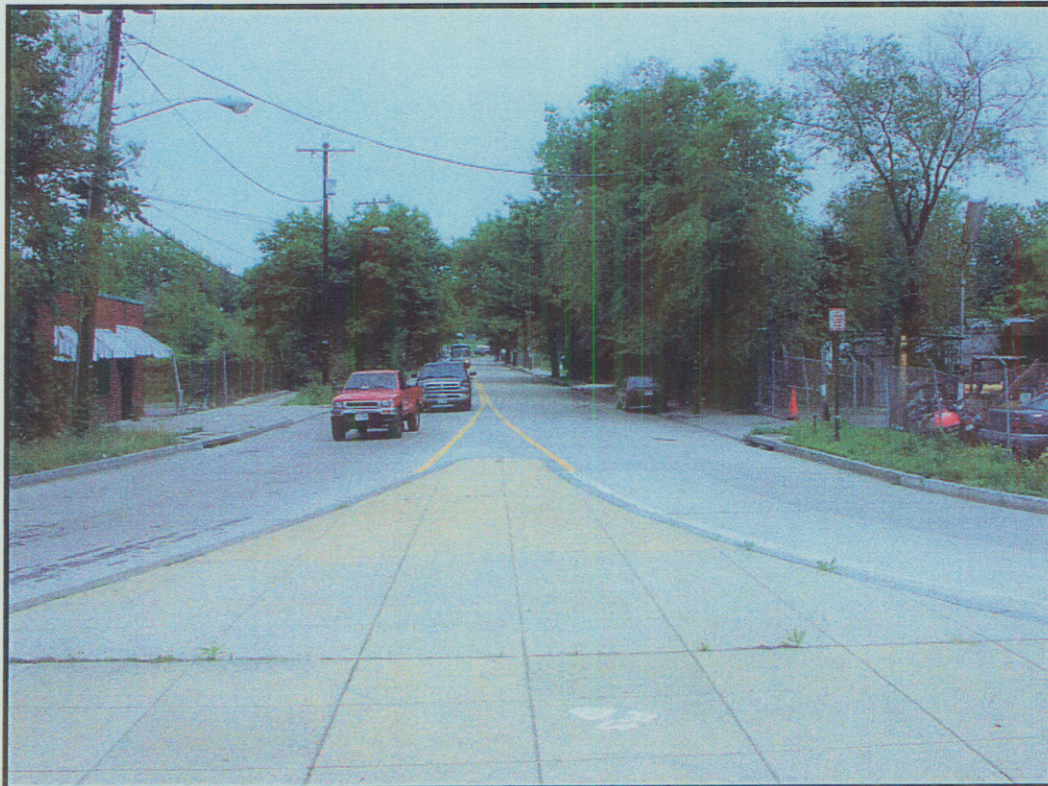
Green Fuel Oil Inc. and an automobile scrap yard were observed in the vicinity of the Properties located near Howard Road S.E. at the time of the observational walkover. The Green Fuel Oil Inc. and automobile scrap yard properties appeared to represent RECs in connection with the Project Study Area due to the presence of potentially hazardous substances and staining on the ground surface.

Photo 6: View down Howard Road S.E. from Suitland Parkway, facing southeast. Note: Green Fuel Oil, Inc. on left side of photograph and automobile scrap yard on right side of photograph.

Prior to initiating restoration efforts, additional investigations should be conducted to assess the significance of the five sites of environmental concern located within Project Study Area. In addition, investigations should be completed to assess impacts related to the Green Fuel Oil, Inc. and automobile scrap yard properties.

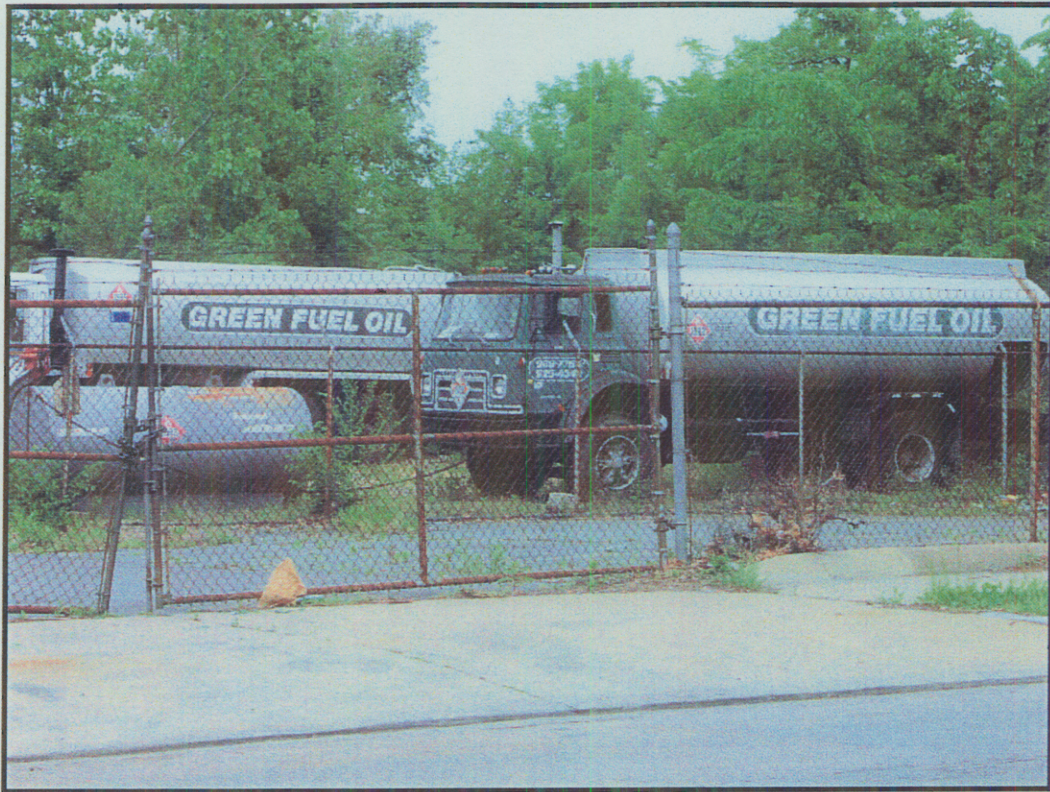
Green Fuel Oil Inc. is located approximately 140 feet east of 5860-938. Five above ground storage tanks (ASTs) and several fuel trucks were observed on the Green Fuel Oil Inc. property. Staining was observed on the one of the ASTs and on the ground surface beneath the AST. The ASTs, staining, and fuel trucks observed on the Green Fuel Oil Inc. property appeared to represent a REC in connection with the Project Study Area.

Photo 7: Fuel trucks located on southern portion of Green Fuel Oil, Inc. property, facing northeast. Note: diesel fuel AST on left side of photograph.

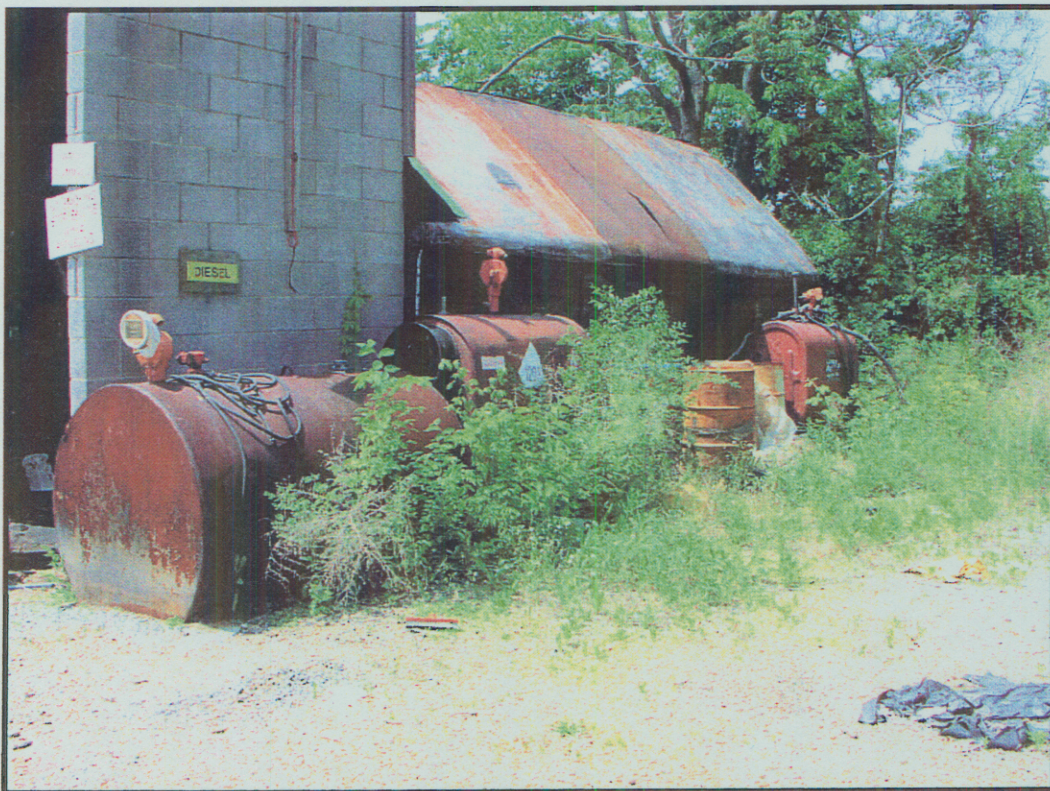
At the time of Ridolfi's observational walkover no evidence of underground storage tanks (USTs), such as vent and fill pipes and concrete pads, were observed on the Properties. Five ASTs and several fuel trucks were observed on the Green Fuel Oil Inc. property located approximately 140 feet east of Property 5860-938. The five ASTs consisted of two diesel fuel ASTs, one kerosene AST, one Duralane AST, and one gasoline AST. Staining was observed on the Duralane AST and on the ground surface beneath the AST. The ASTs, staining, and fuel trucks observed on the Green Fuel Oil Inc. property appeared to represent a REC in connection with the Project Study Area.

Photo 8: ASTs located near central portion of Green Fuel Oil, Inc. property, facing southwest.

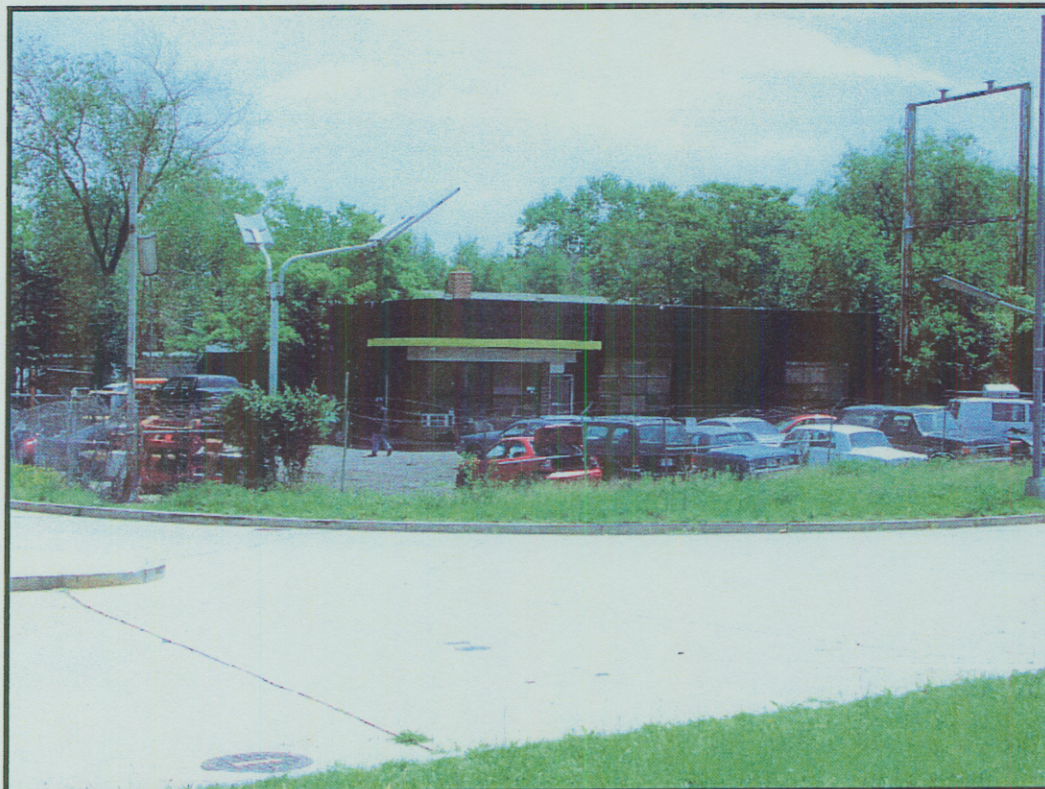
An automobile scrap yard and a trailer storage yard adjoin 5861-943, 5861-942, and 5861-950 to the northeast. Several scrap automobiles, automobile parts, and debris were observed on the automobile scrap yard property. Staining was observed on the ground surface near some of the debris located on the scrap yard property. The staining and scrap automobiles represented a REC in connection with the Project Study Area.

Photo 9: Overview of automobile scrap yard located near southeast corner of Howard Road S.E. and Suitland Parkway, facing southeast.

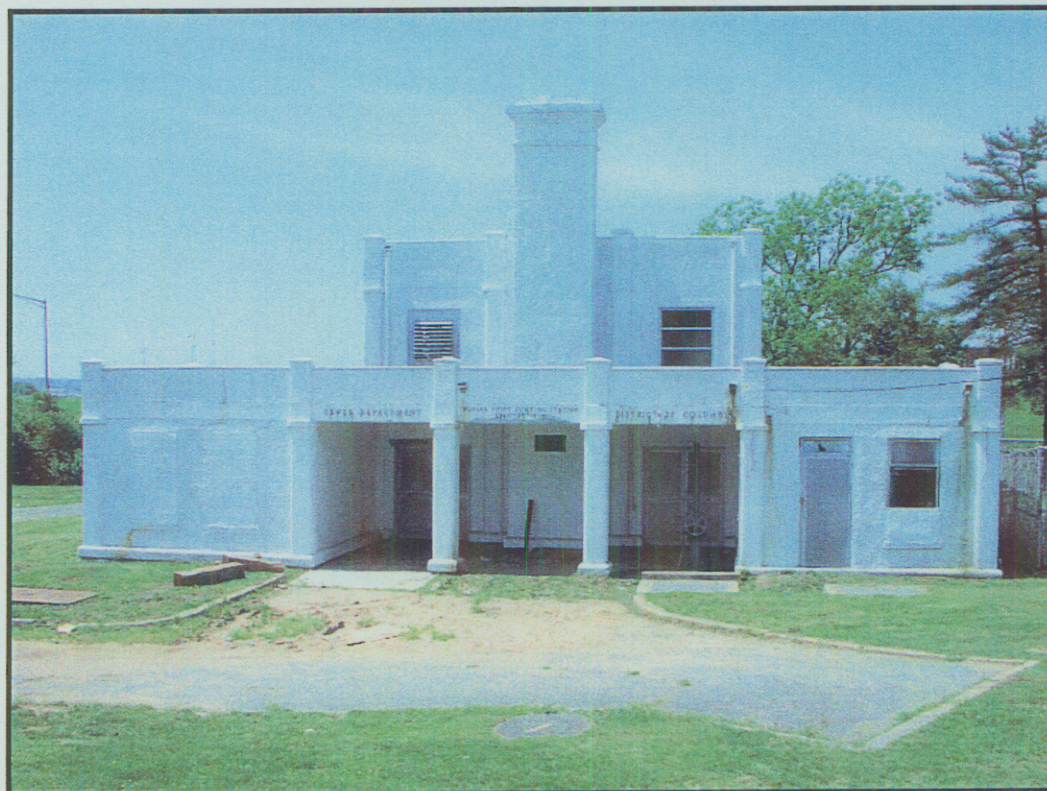
Five pad-mounted electrical transformers were observed near the northern portion of the District of Columbia Poplar Point Sanitary Sewer Pump Station, which adjoins 5861-945 to the west. No signs of staining were observed on the transformers or on the ground surface beneath the transformers. The transformers did not appear to represent a RECs in connection with the Project Study Area.

Photo 10: District of Columbia Poplar Point Sewage Pumping Station, facing west.
